# New Hampshire Volunteer Lake Assessment Program

## 2002 Bi-Annual Report for Jenness Pond Northwood

NHDES  
Water Division  
Watershed Management Bureau  
6 Hazen Drive  
Concord, NH 03301

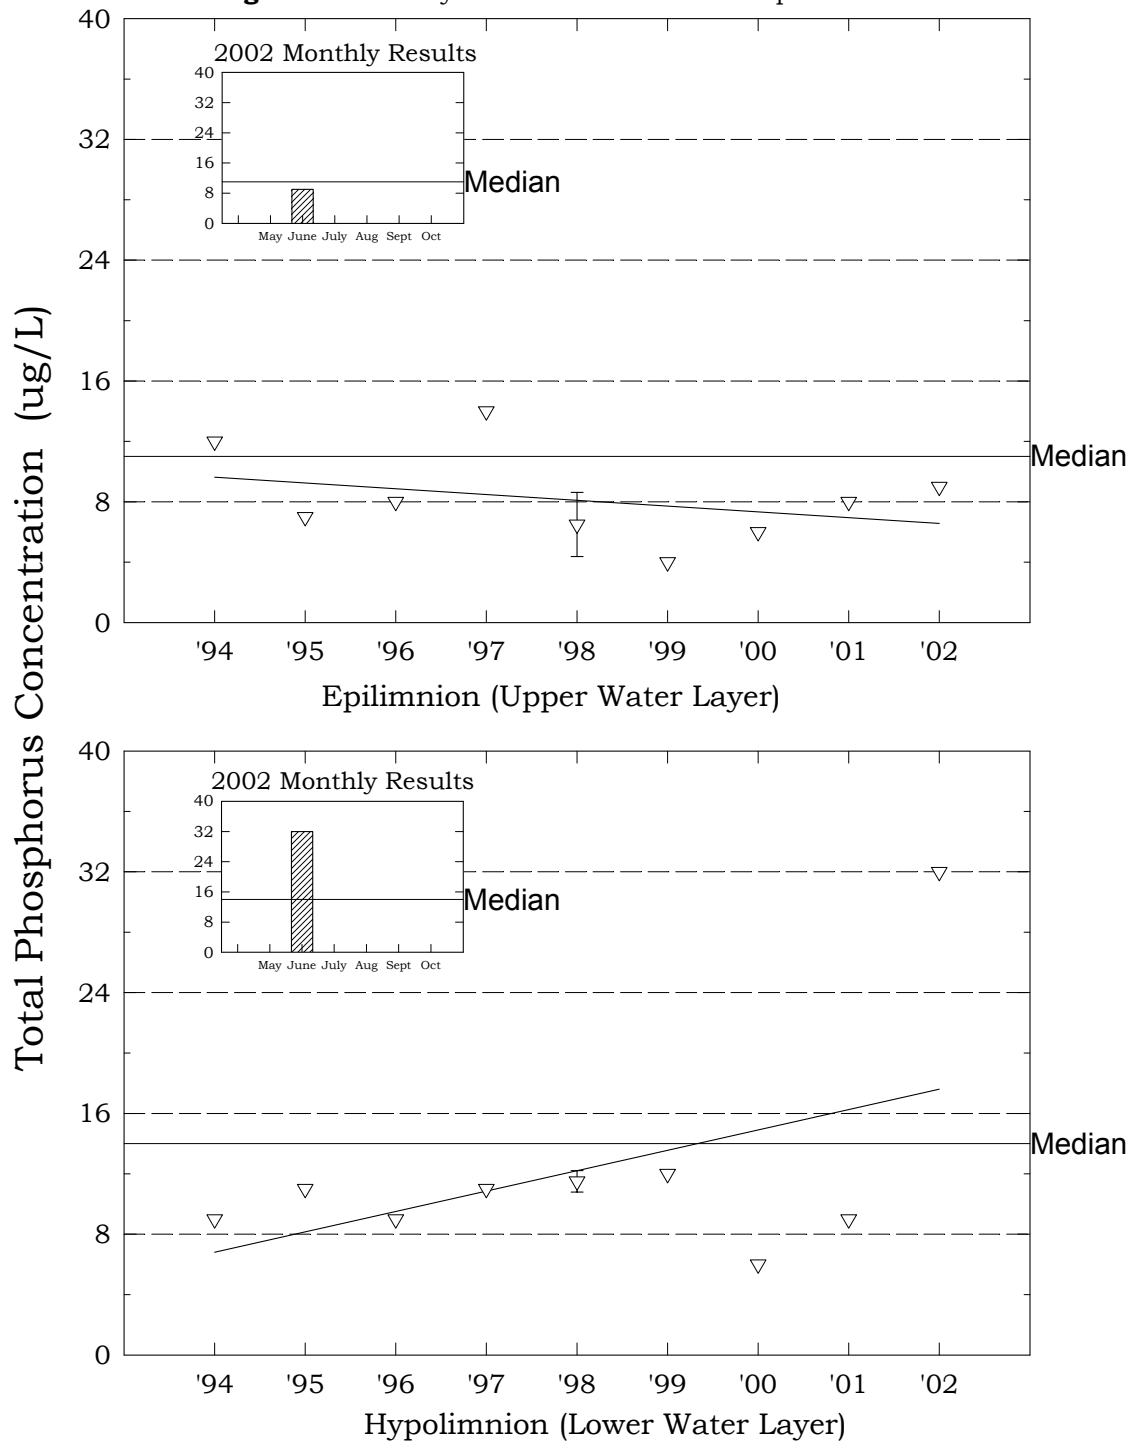
**Figure 3.** Monthly and Historical Total Phosphorus Data.

- **Figure 3 and Table 8:** The graphs in Figure 3 (Appendix A) show the amounts of phosphorus in the epilimnion (the upper layer) and the hypolimnion (the lower layer); the inset graphs show current year data. Table 8 (Appendix B) lists the annual maximum, minimum, and median concentration for each deep spot layer and each tributary since the lake/pond has joined the program.

The current year data for the epilimnion (the top inset graph) show that the total phosphorus concentration in June was ***slightly less than*** the state median.

The current year data for the hypolimnion (the bottom inset graph) show that the total phosphorus concentration in June was ***much greater than*** the state median. In fact, the phosphorus concentration was the ***greatest*** concentration measured since monitoring began in 1994. The turbidity of the sample was ***not*** elevated, which suggests that the lake bottom was ***not*** disturbed while sampling. We will watch the data for the hypolimnion closely next season to see if phosphorus concentration continues to remain elevated.

Overall, visual inspection of the historical data trend line for the epilimnion show a ***variable*** total phosphorus trend, which means that the concentration has ***fluctuated*** in the epilimnion since monitoring began in 1994.

Overall, visual inspection of the historical data trend line for the hypolimnion shows ***an increasing*** total phosphorus trend, which means that the concentration has ***worsened*** in the hypolimnion since monitoring began. (Note: This increase is due to the high concentration that was observed in the hypolimnion this season.)

We recommend that your monitoring group expand its monitoring program to include ***three*** sampling events per season. This will allow us to analyze long-term trends in the quality of the pond with more confidence and accuracy.

One of the most important approaches to reducing phosphorus loading to a waterbody is to continually educate watershed residents about its sources and how excessive amounts can adversely impact the ecology and value of lakes and ponds. Phosphorus sources within a lake or pond's watershed typically include septic systems, animal waste, lawn fertilizer, road and construction erosion, and natural wetlands. If you would like to educate watershed residents about how they can help to reduce phosphorus loading into the lake/pond, please contact the VLAP Coordinator.
